MUMBAI HIGH NORTH ACCIDENT

Presentation to Oil & Gas UK Seminar: 6 June 2007

HSE Offshore Division

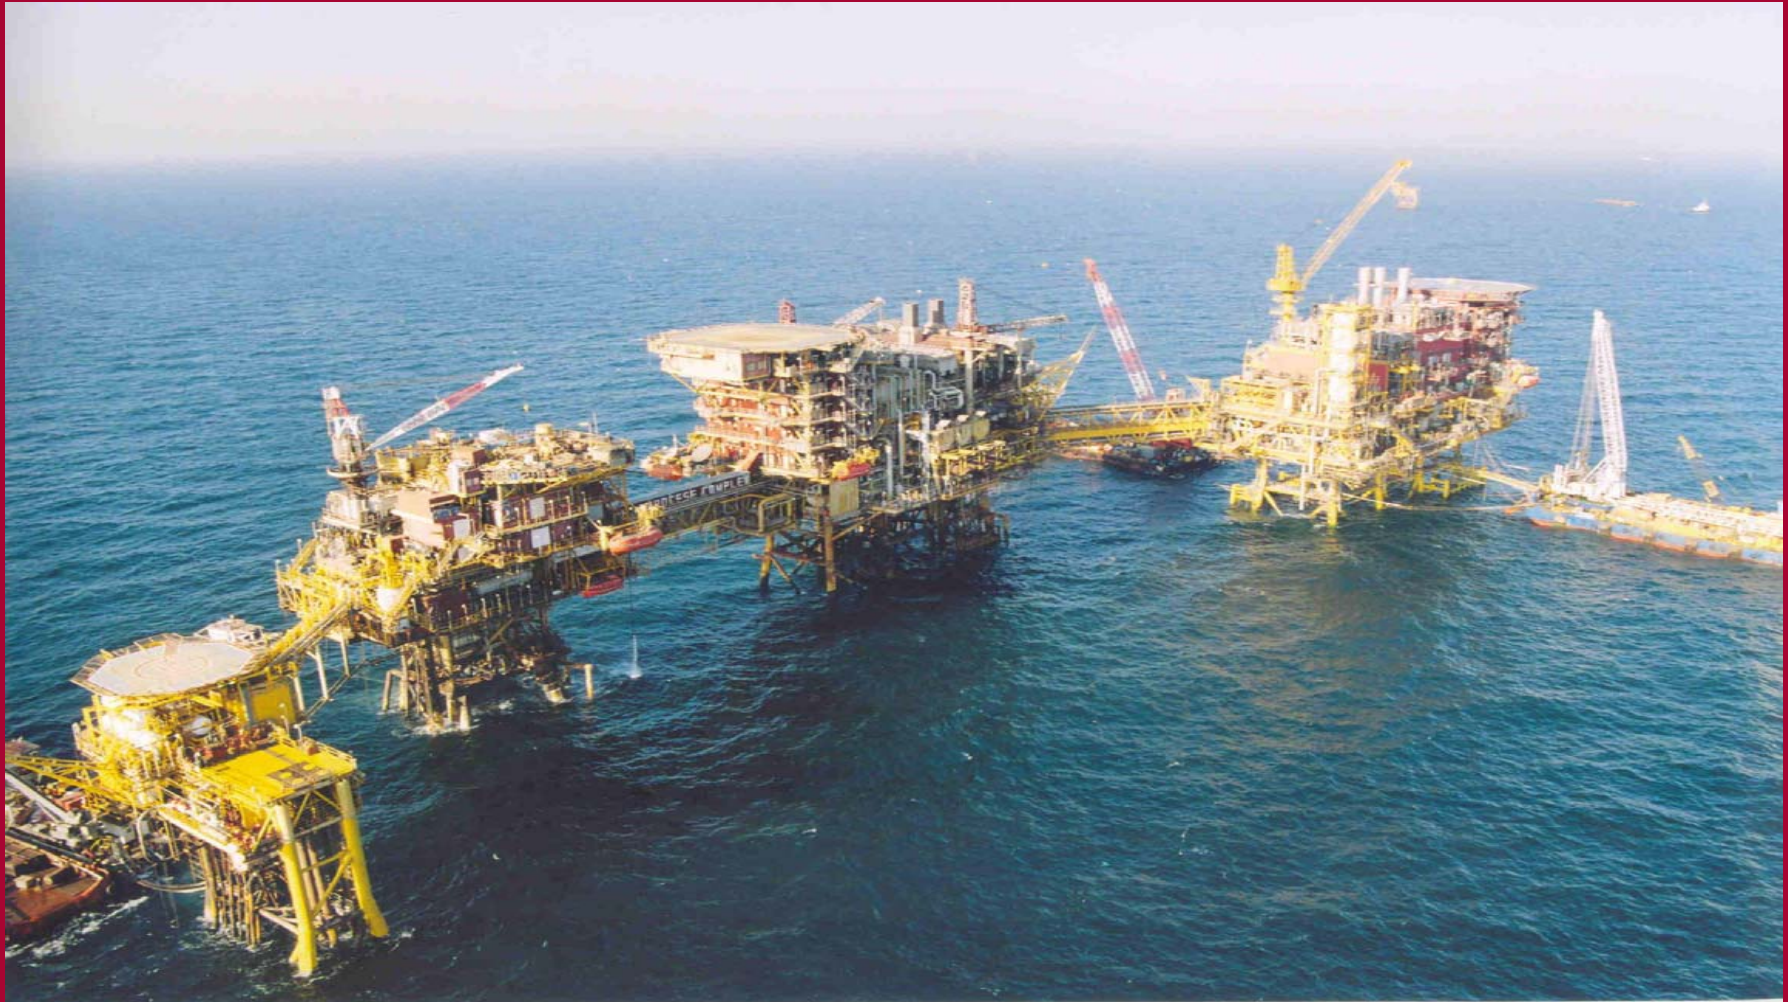
Mumbai High North Complex

- The Mumbai High North complex consists of four bridge-linked platforms, approx 100 kms offshore.
- NA is a small wellhead platform, circa 1976 (first offshore well in India).
- MHF is residential (1978)
- MHN is a processing platform (1981)
- MHW is a relatively recent additional process platform.
- Next slide: (L->R) NA – MHF – MHN - MHW
